# **Power system damage, recovery and challenges from Great East Japan Earthquake**

Makoto Toyoma

The Federation of Electric Power  
Companies of Japan

February 4, 2013

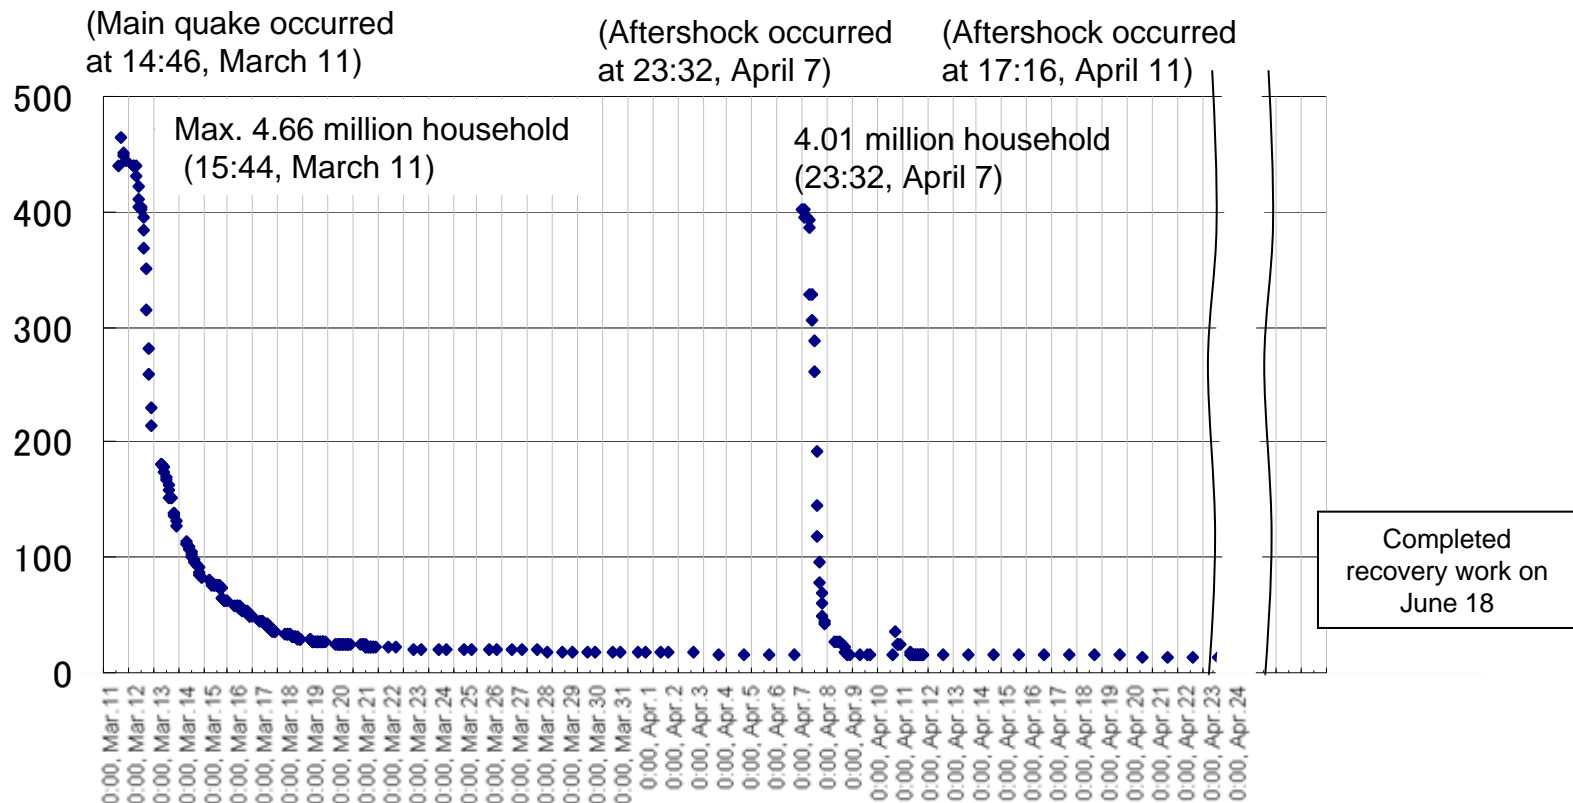
- Within the area supplied by Tohoku Electric Power, the problems of supply were resolved at 20:00, March 19, 2011 except for the areas where they couldn't start the recovery work due to the effects of Tsunami, etc. Although partly affected by the aftershock on April 7, the problems of supply were completely resolved on June 18 except for the areas where they couldn't do the recovery work.

Number of household with power outage (10 thousand households)

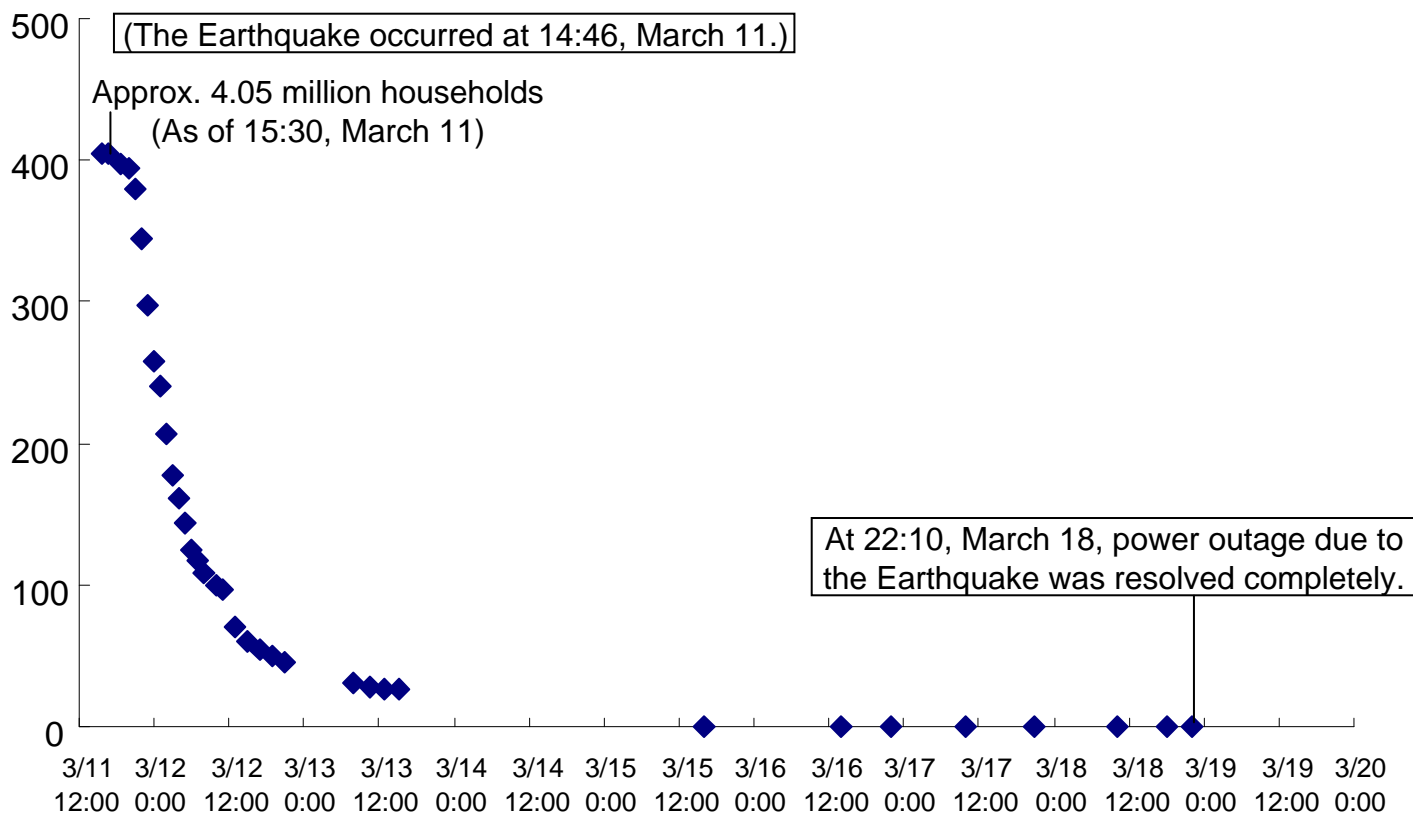
**■ The supply problems were resolved at 22:10, March 18, 7 days after the Earthquake, within the area supplied by TEPCO.**

Number of household with power outage  
(10 thousand households)

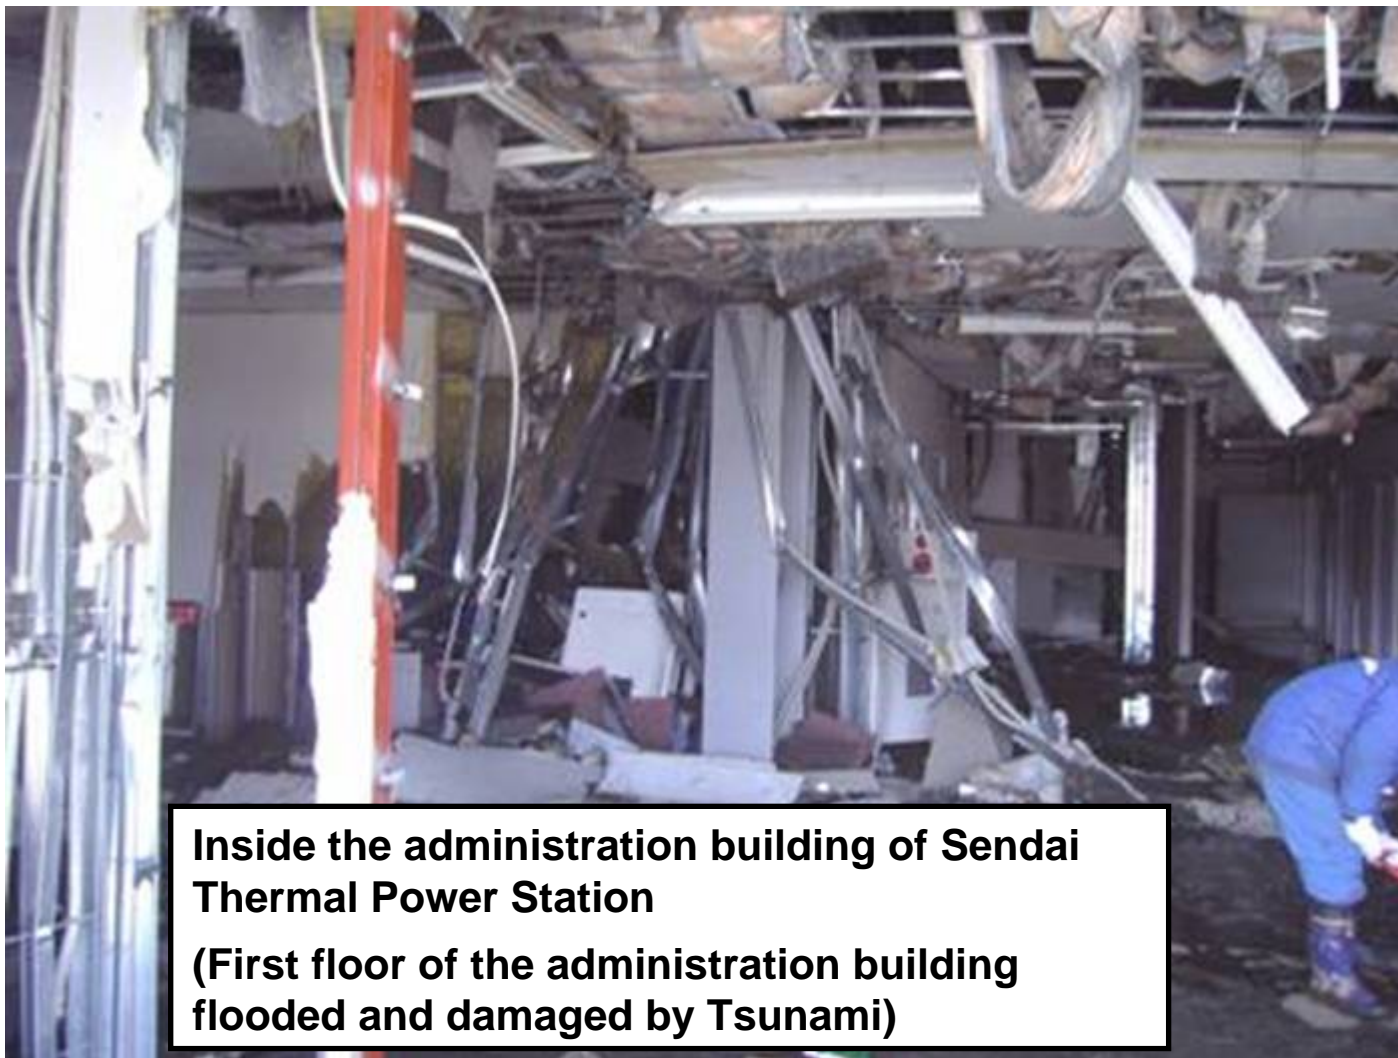
# ① Sendai Thermal Power Station

**Inside the administration building of Sendai Thermal Power Station**

**(First floor of the administration building flooded and damaged by Tsunami)**

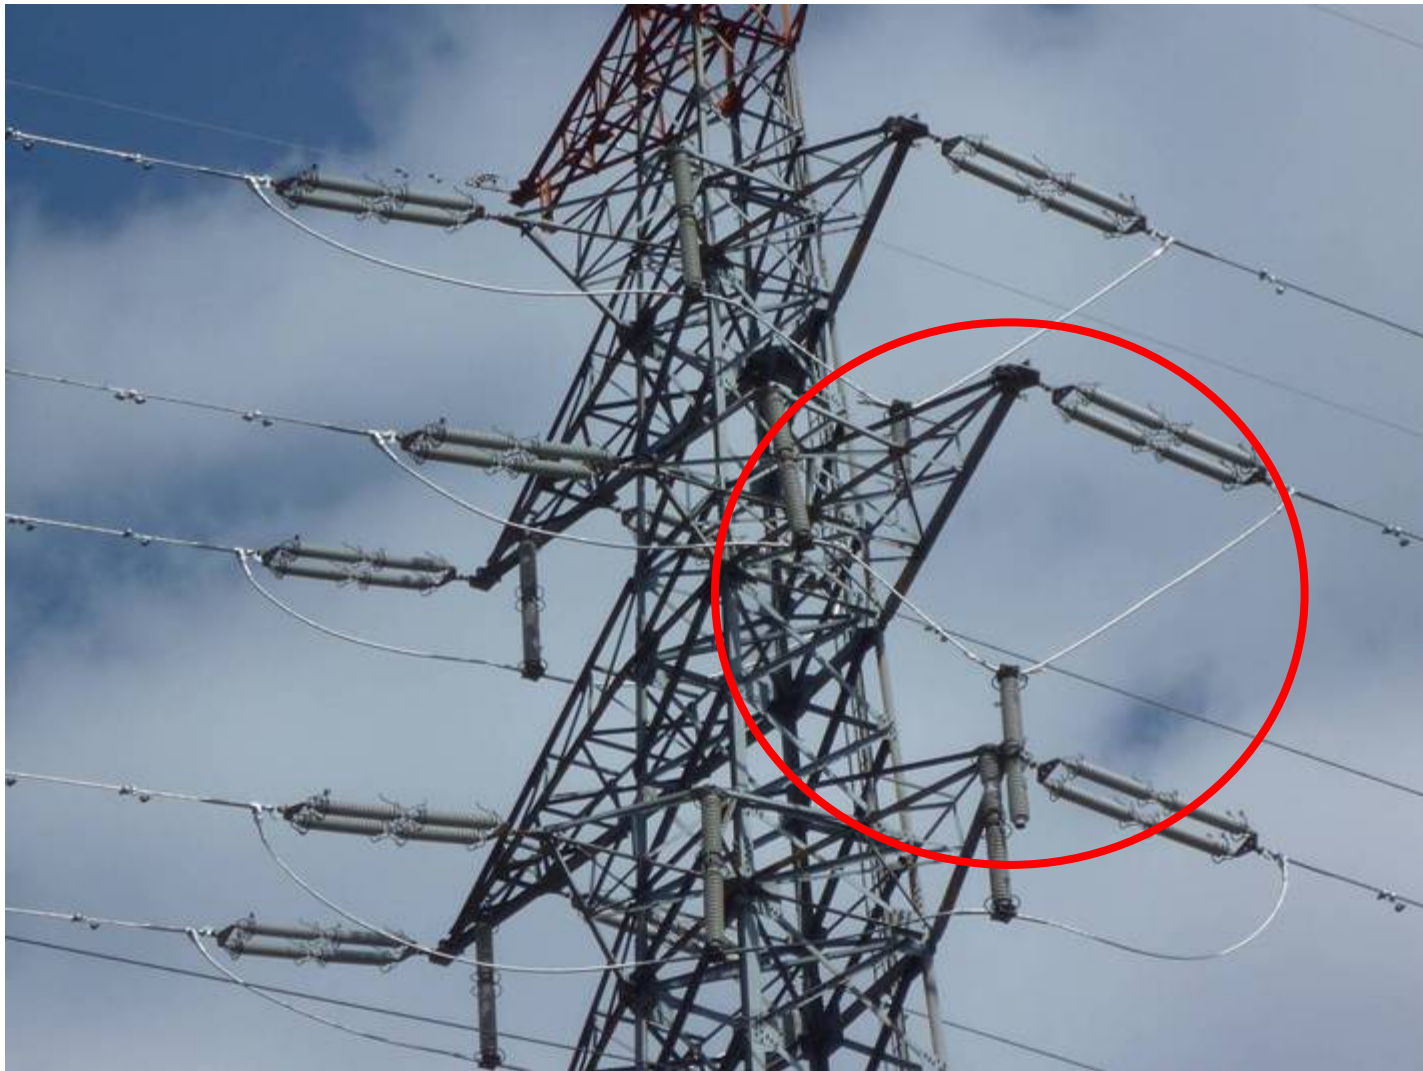
# -Tohoku Electric Power Transmission facilities ① -

Broken supporting insulator

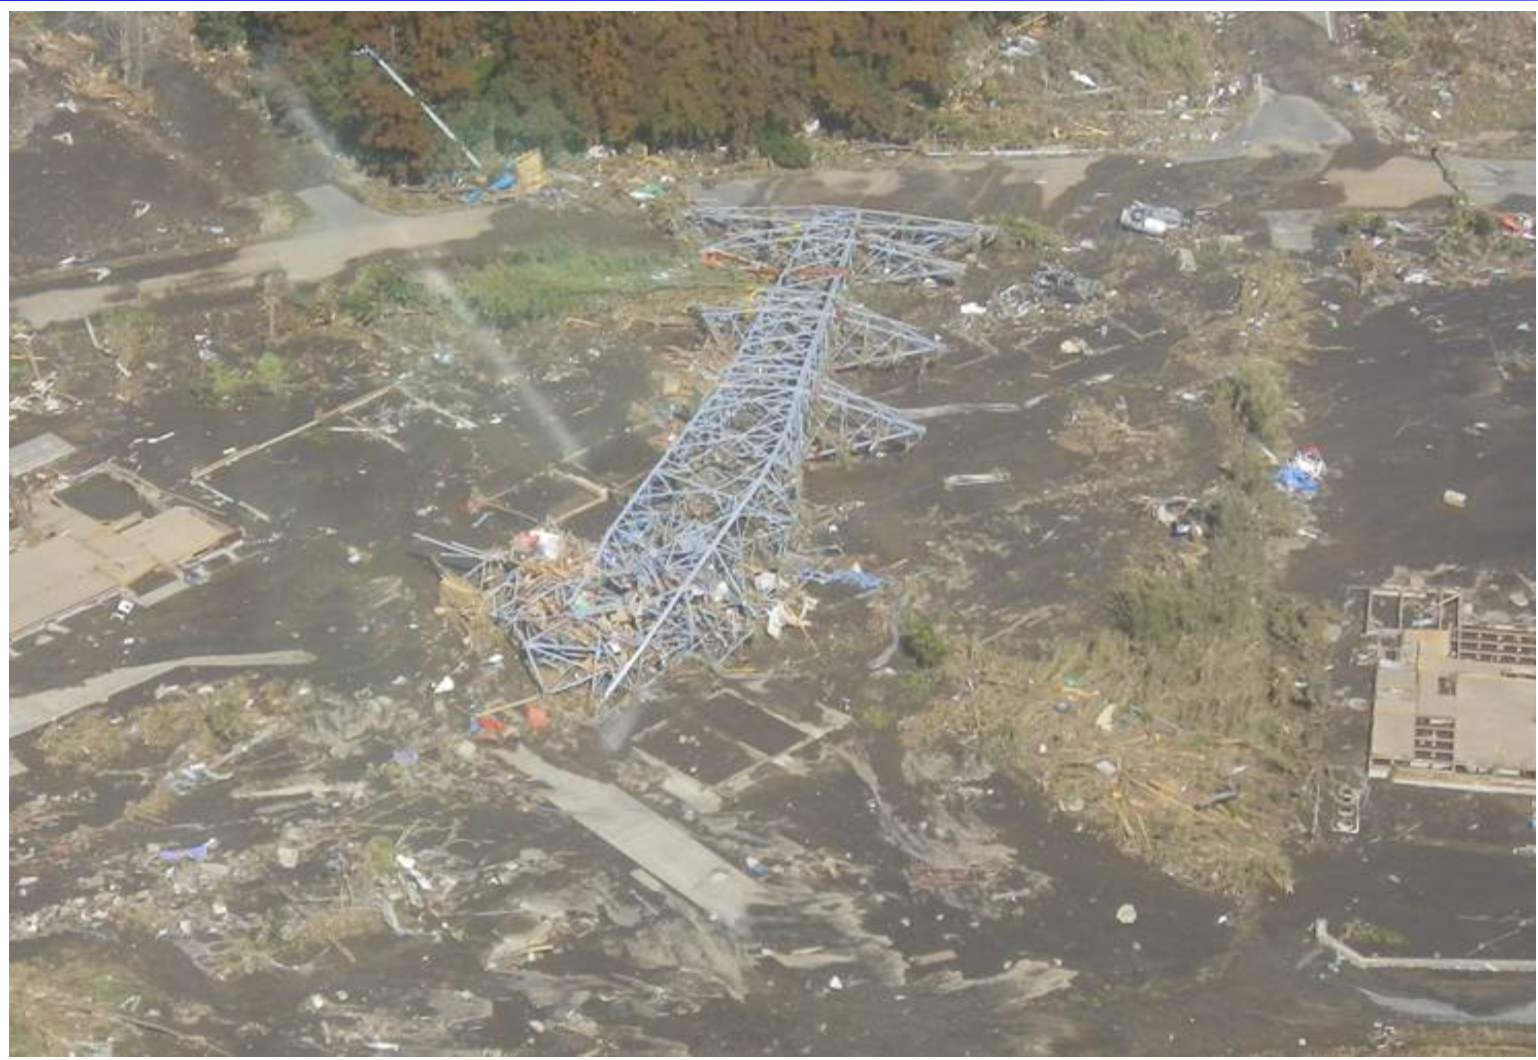
# -Tohoku Electric Power Transmission facilities ② -

Tsunami damage (Collapsed steel tower)

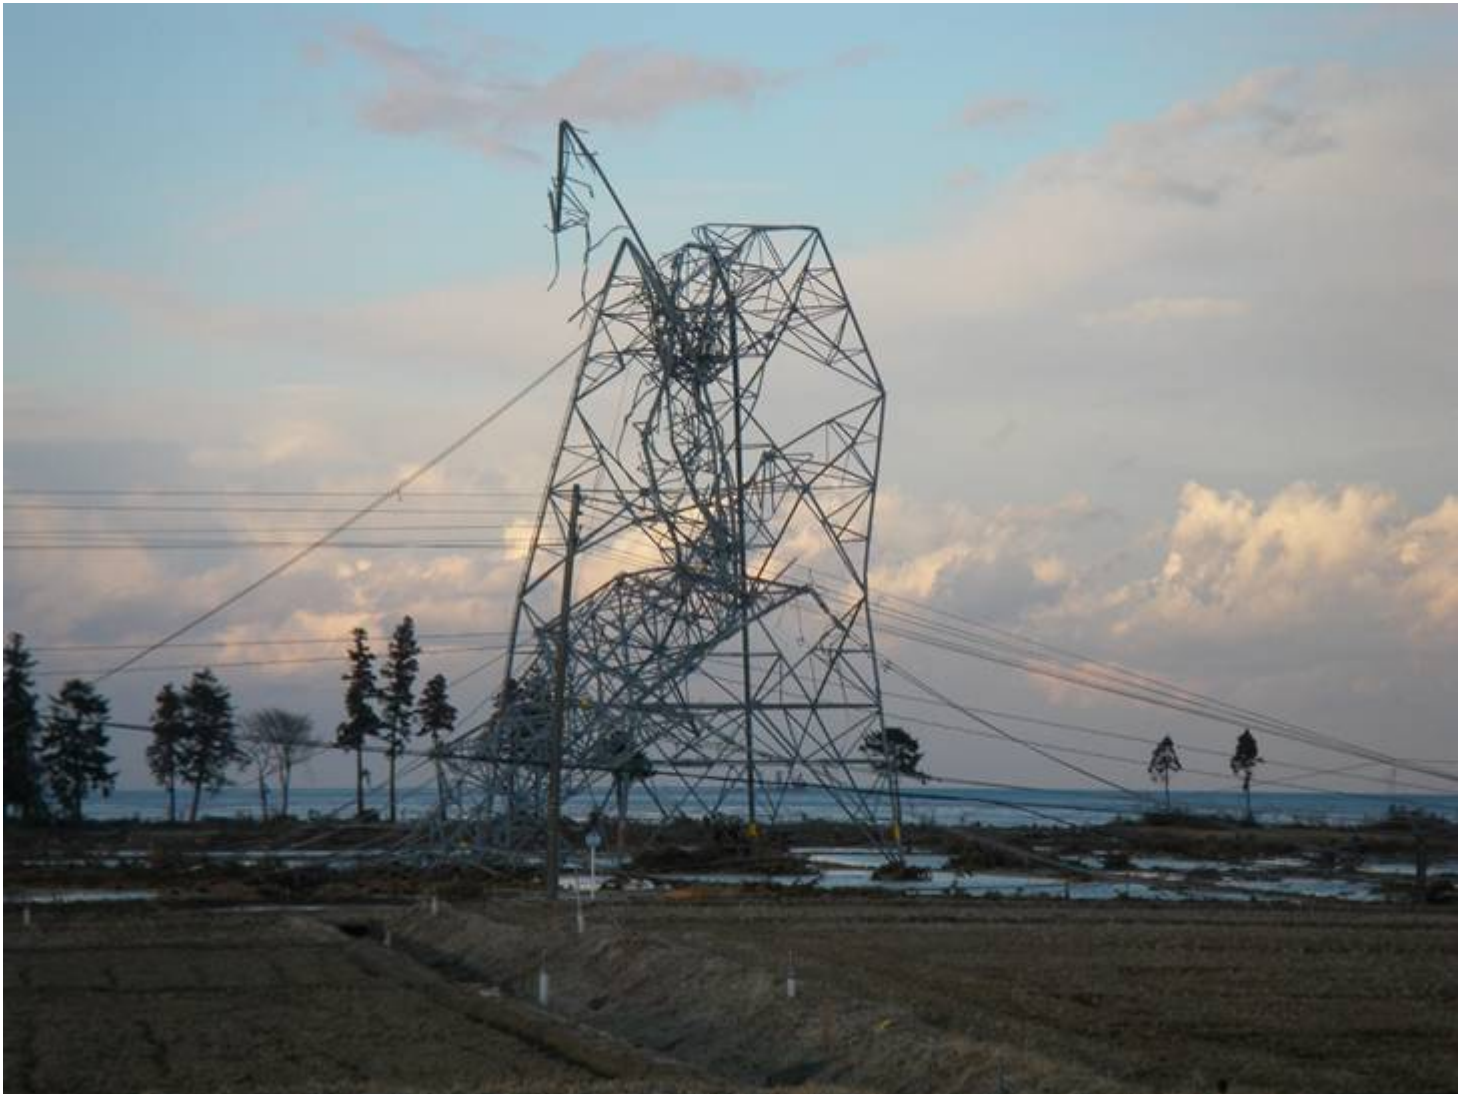
## -Tohoku Electric Power Transmission facilities ③ -

Tsunami damage (Broken steel tower)

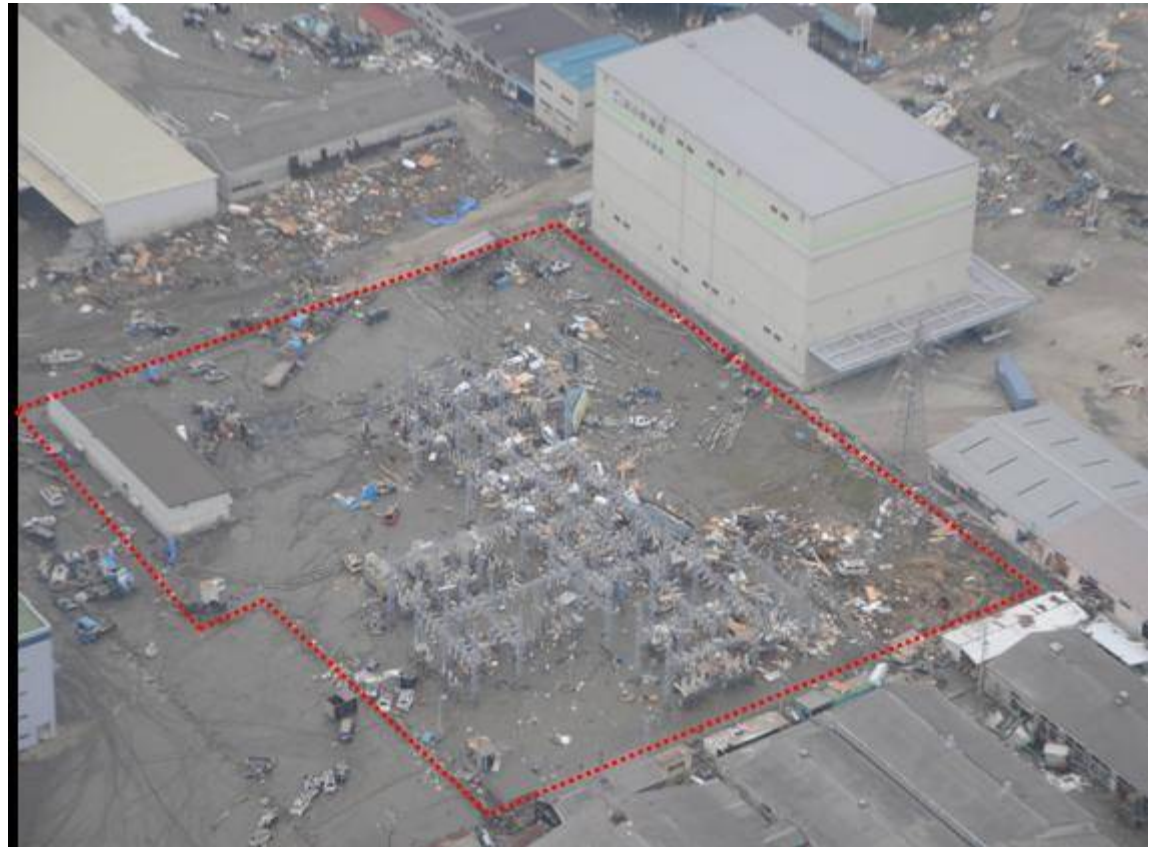
# -Tohoku Electric Power Transforming facilities ① -

Tsunami damage

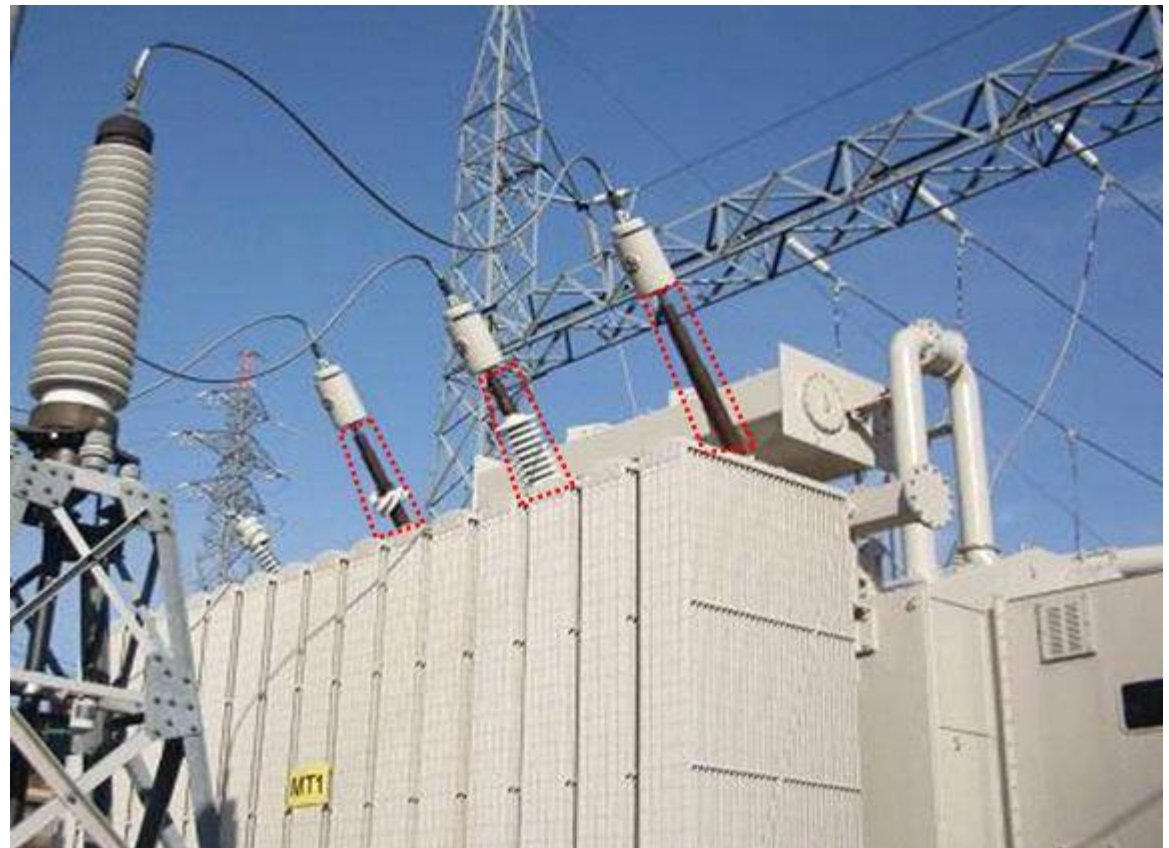
# -Tohoku Electric Power Transforming facilities ②-

Damaged transformer bushing

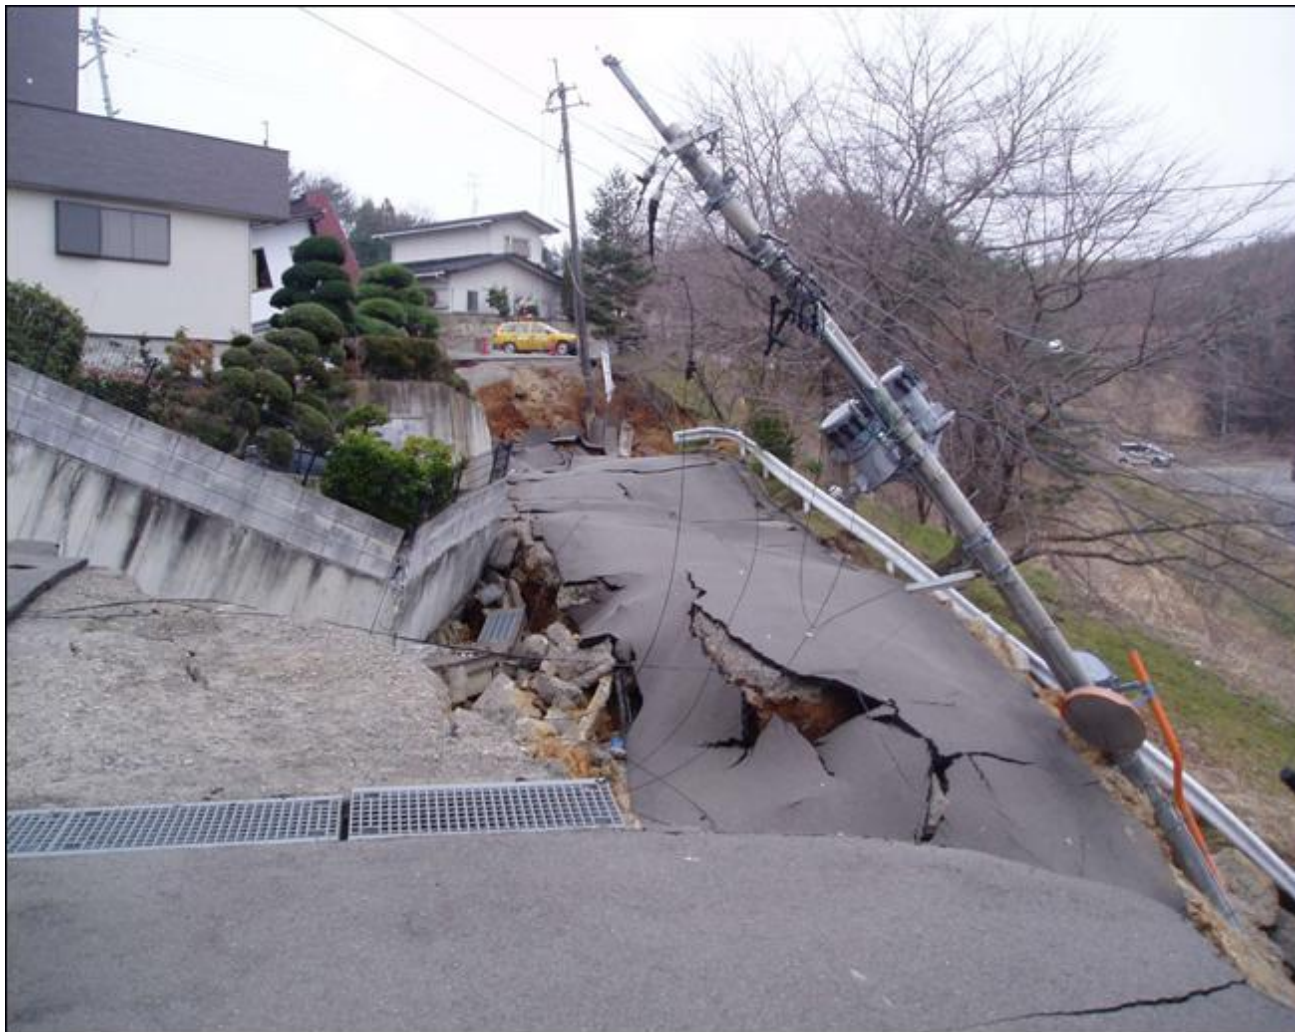
## -Tohoku Electric Power Distribution facilities -

**Pole inclined due to damage to the road  
(Fukushima City, Fukushima Prefecture)**
